DOCKET NO. SA-228

EXHIBIT NO. 20A

CARGO/FIRE GROUP CHAIRMAN'S FACTUAL REPORT

Accident Number: DCA06MA022
Operator: United Parcel Service Company
Location: Philadelphia International Airport (PHL), Philadelphia, PA
Date: February 7, 2006
Time: 2359 Eastern Standard Time (EST)
Airplane: DC-8-71F, N748UP

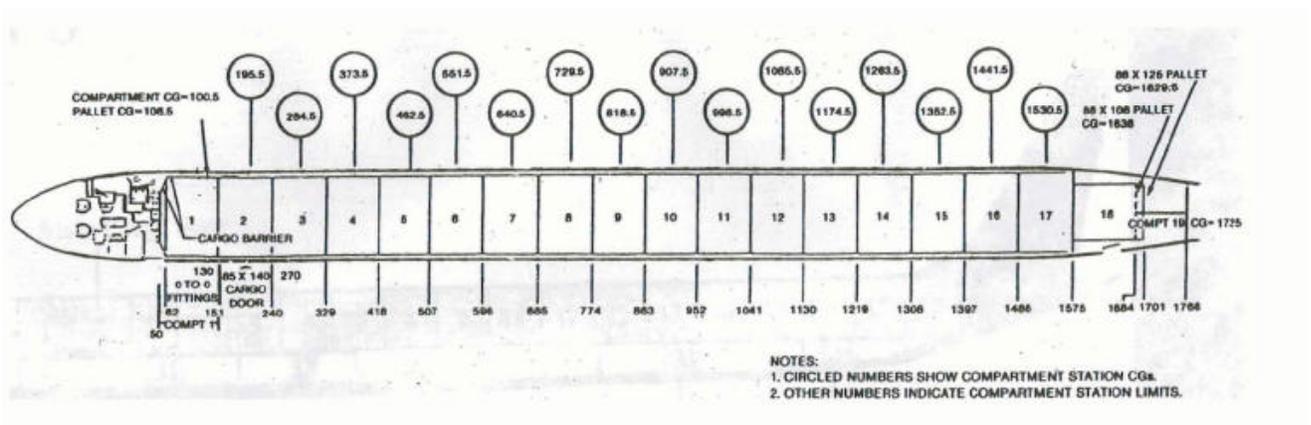
Figure 4: Diagram of Position Location and Frame Stations.

The forward part of the aircraft was heavily sooted. Up to Frame Station (FS) 702, there was no structural damage and the liners were still in place.

At FS 702.875, FS 717.750, FS 742.250, FS 759.000, FS 781.500, the structure was sagging, bent and white in color. Partial frames were present on longeron L-6 on the left to L-6 on the right side.
